DoD Corrosion Prevention and Control Program

Demonstration and Validation of a Composite Grid Reinforcement System for Bridge Decks

Final Report on Project F12-AR01

September 2016

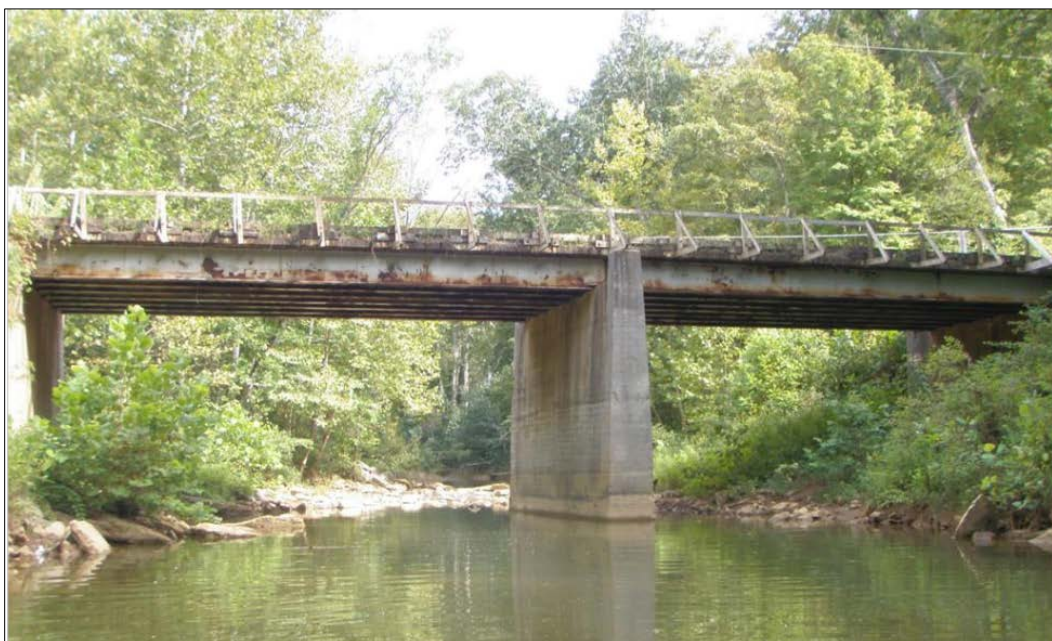
Figure 1. Bridge No. 4 at Fort Knox.

Bridge No. 4 (Figure 1) in the Fort Knox training range was one of the bridges scheduled for rehabilitation of its corroded support beams and deteriorating bridge deck. With Bridge No. 4 having two spans, it was an excellent candidate for concurrent demonstrations of a hybrid-composite beam (HCB) and the grid composite deck reinforcement technologies.

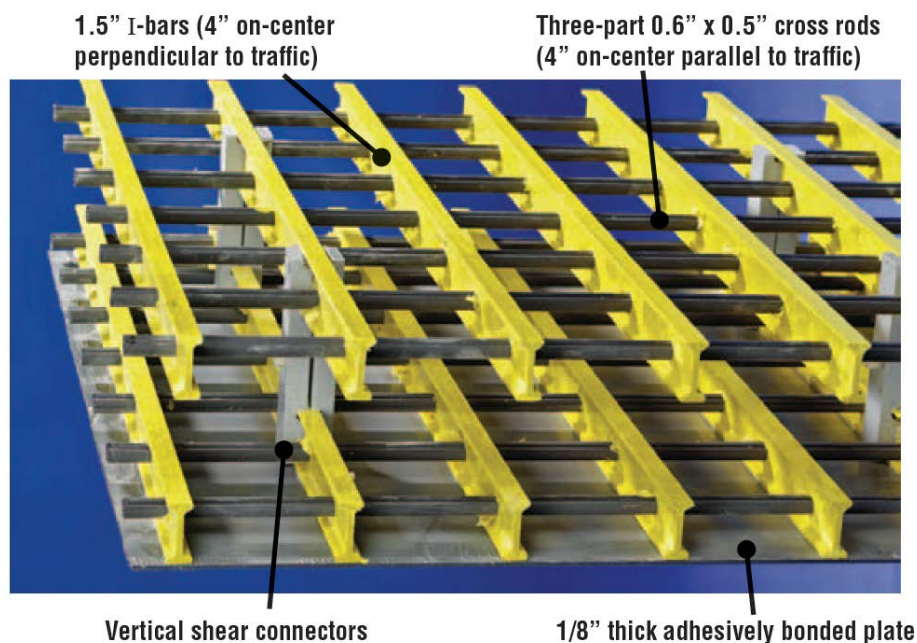
Figure 2. Section of the 3-D Gridform reinforcement.

A Gridform bridge deck system is designed to replace steel rebar in reinforced concrete bridge decks. Gridform consists of two layers of pultruded grating members that are separated by FRP shear connectors with nylon bolts. The grating is formed from I-shaped cross-sections (called I-bars) that are situated in the lengthwise direction 4 in. on center, with cross rods in the perpendicular direction also on 4 in. spacing. Gridform also has a 1/8 in. pultruded FRP plate bonded to the bottom grating layer that creates a stay-in-place concrete form which simplifies installation and reduces construction time (Figure 2; Bank, Olivia, and Brunton 2011).

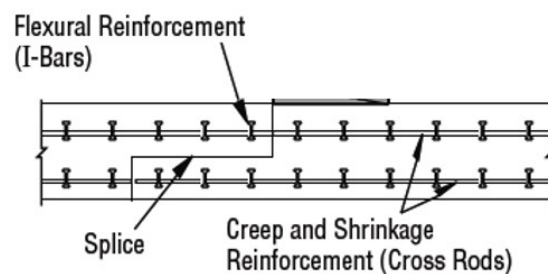
Figure 3. Gridform cross-section showing panel overlap at the splice.

The FRP reinforcement sections were delivered to the site precut by the manufacturer (approximately 4 x 27 ft) to fit the dimensions of the bridge, with each layer on each section offset to create a splice joint (Figure 3). The two end sections did not contain the layer offset. Figure 4–Figure 6 depict different views of section installation, showing that only one crane lift is needed for placement. Once the sections were lowered onto the beams, the sections could be manipulated into position by hand. Ten sections were installed in the 38.5 ft span. The FRP reinforcement was fastened to the longitudinal steel beams by sandwiching two FRP blocks around the steel beam top flange and the bottom layer FRP I-bars, compressed by stainless-steel bolts, as shown in Figure 8 and Figure 9. Concrete was poured onto the deck using a conventional concrete truck and pump, followed by a concrete vibrator and hand spreading concrete over the FRP reinforcement (Figure 10–Figure 11).

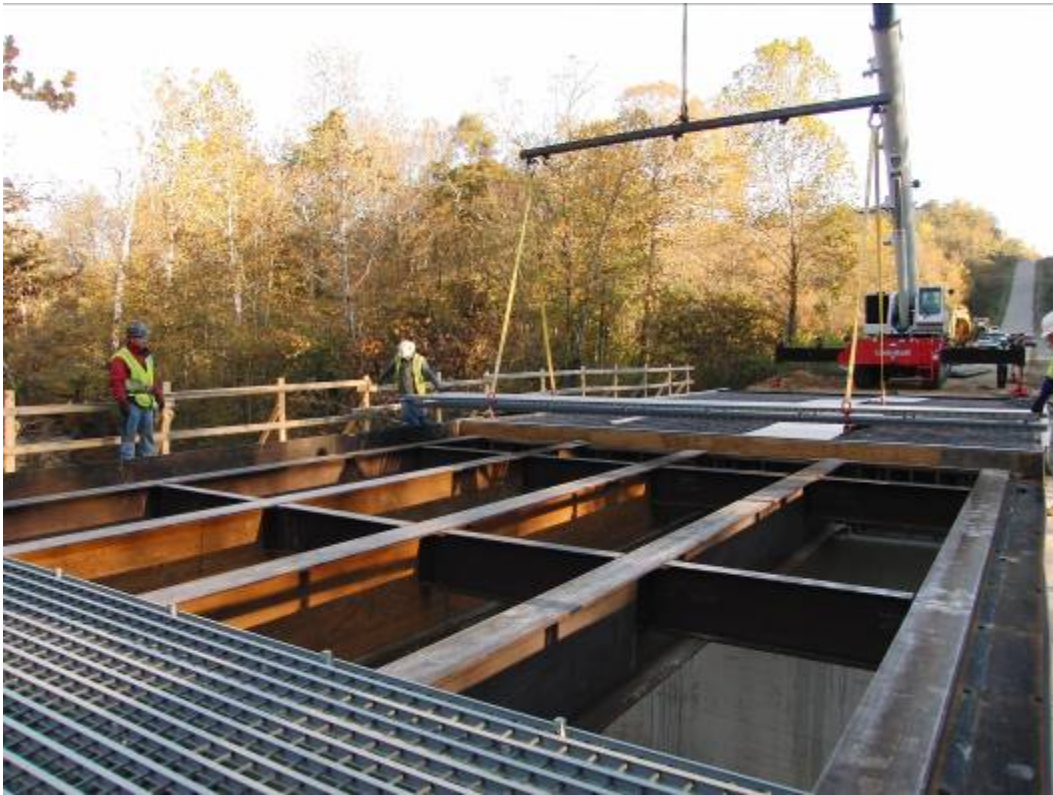
Figure 4. Crane lift of FRP reinforcement panels.

Installation of the FRP reinforcement sections, not including the concrete pour, was completed in 4 hours by a three-person crew and a crane operator. The sections used in this project were light enough to be manipulated into place by hand (Figure 7), once they were positioned by the crane. The labor savings attributable to the section's light weight is a major advantage during installation of this technology. The construction contractor estimated that deck construction time was reduced by at least 80% on this span. More rapid installation of the panels allowed much faster placement of the concrete, saving further time and labor. The Bridge No. 4 contractors estimated that the reduced manpower requirement and speed of installation led to a 75% reduction in total labor costs for this deck, compared to the adjacent steel reinforced concrete deck documented in the companion demonstration report, ERDC/CERL TR-16-22 (Sweeney et al. 2016). The finished bridge deck is shown in Figure 12.

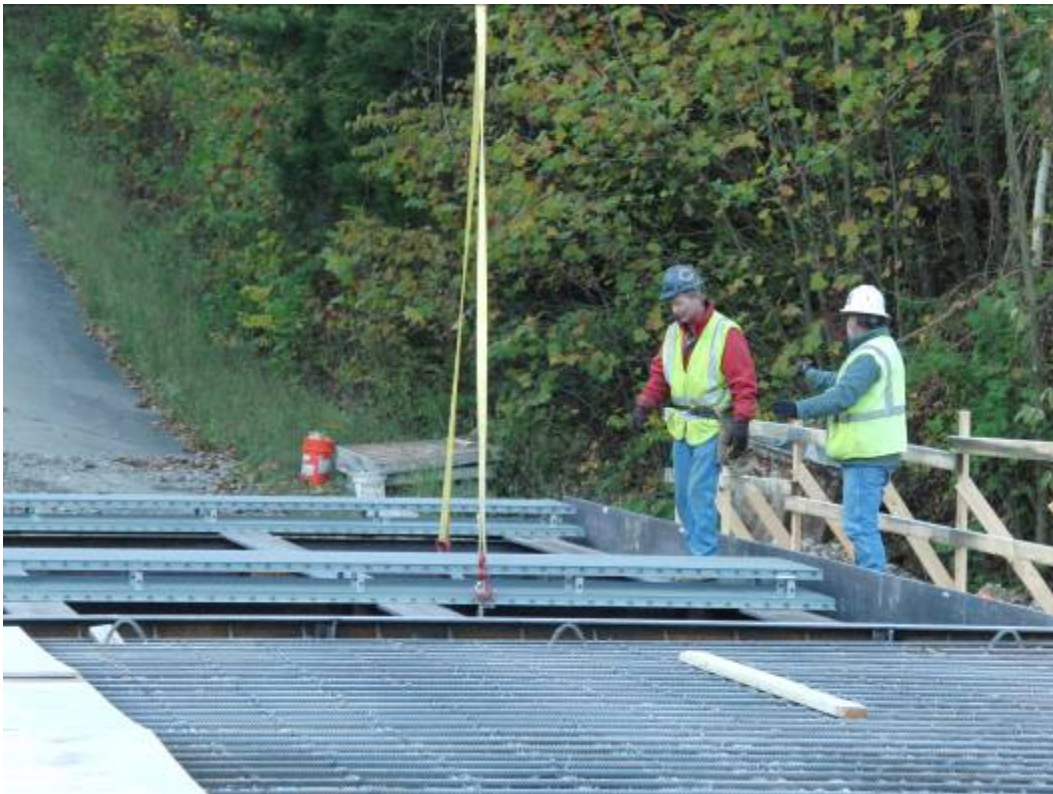
Figure 5. Placing FRP reinforcement panels by crane.

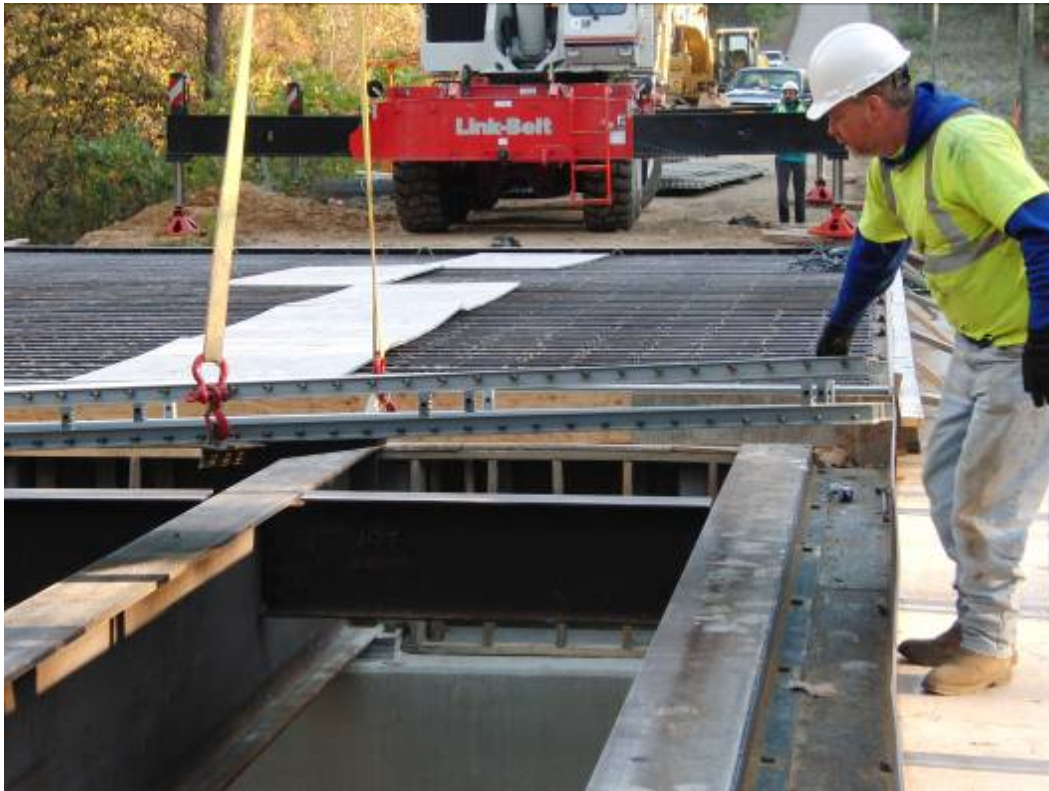
Figure 6. Guiding the FRP reinforcement panel installation.

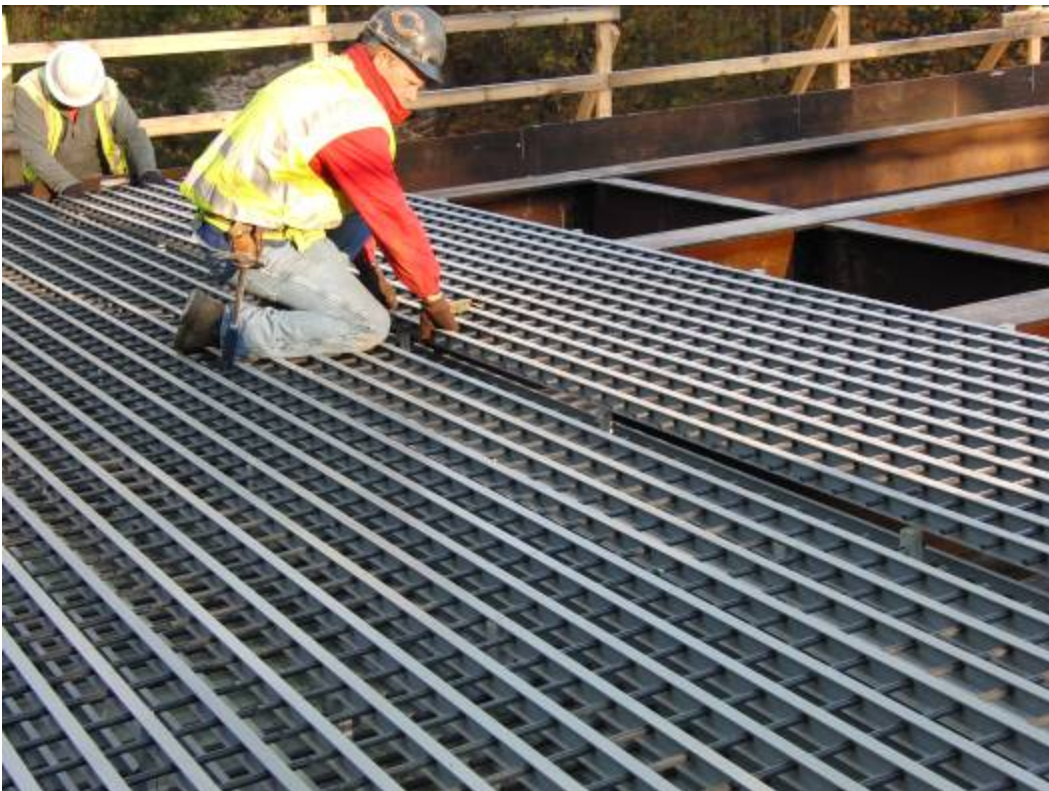
Figure 7. Manipulating the FRP reinforcement panels by hand.

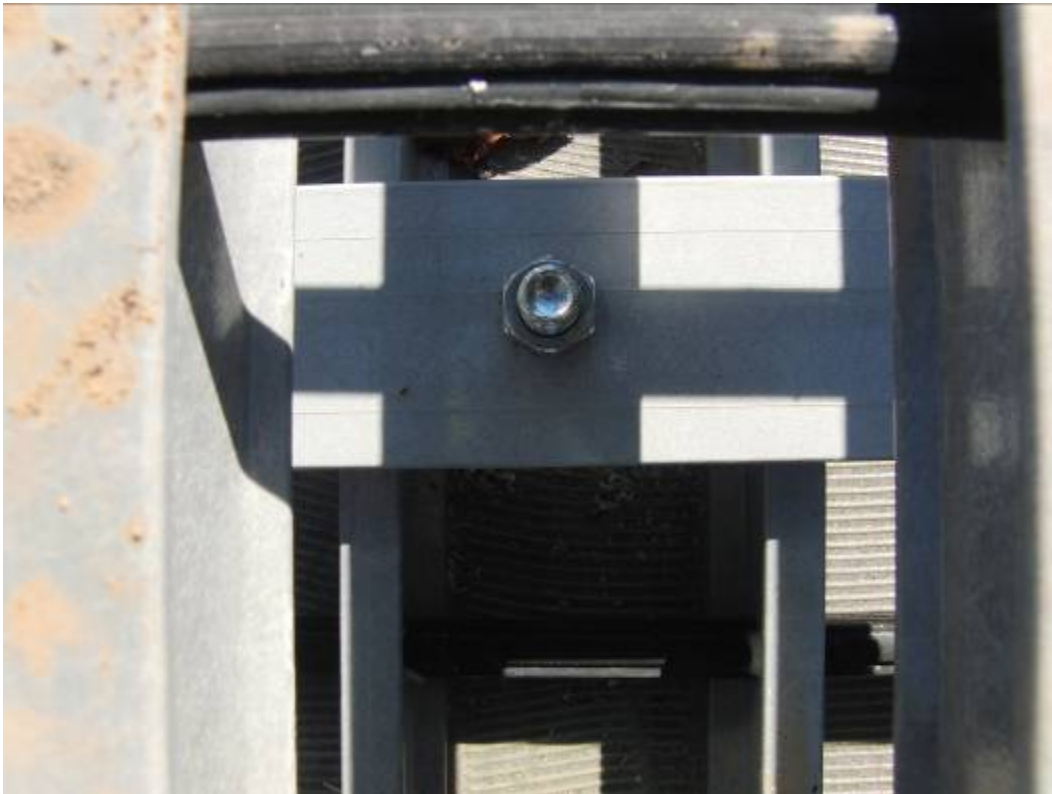
Figure 8. Fastening the bottom layer of FRP I-bars to the steel beam using FRP blocks and stainless steel bolts, shown from above.

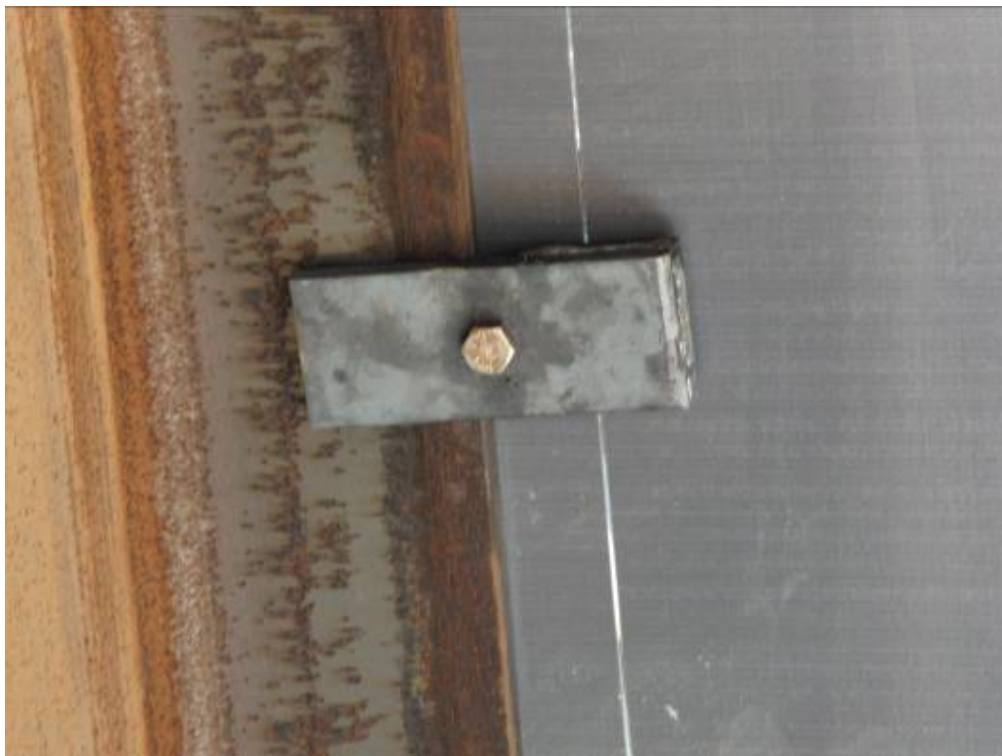
Figure 9. Fastening the FRP reinforcement panels to the top flange of the steel beam, using FRP blocks and stainless steel bolts (shown from below).

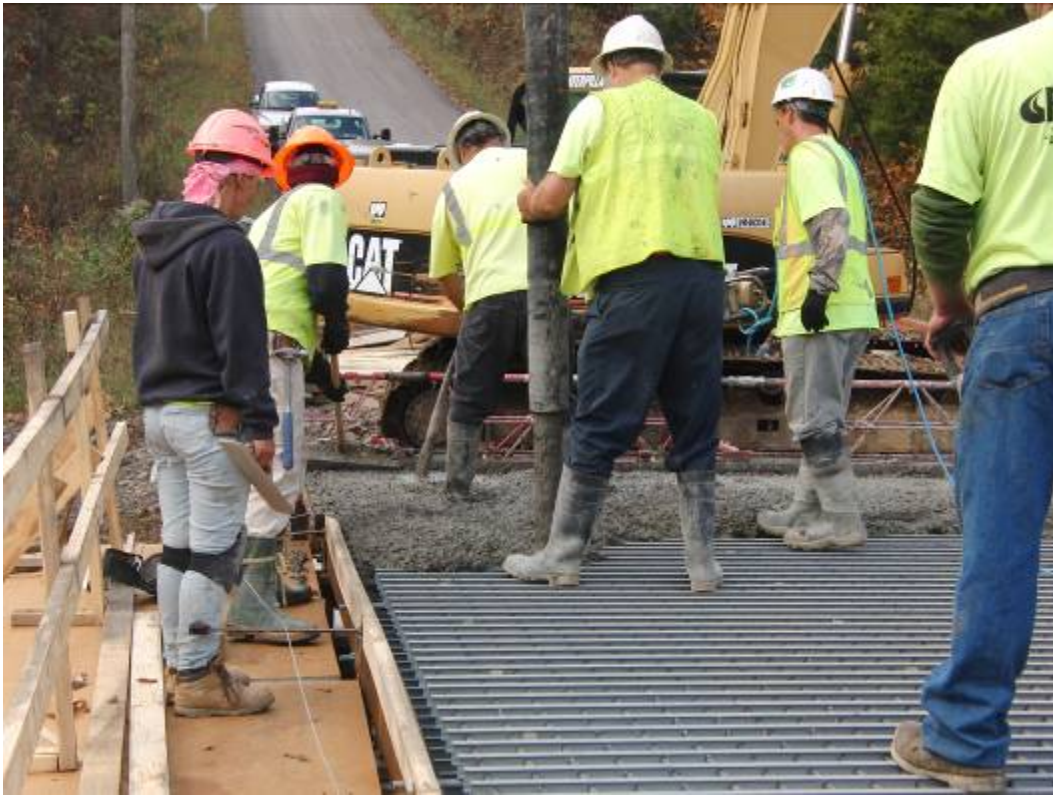
Figure 10. Concrete pouring and vibrating.

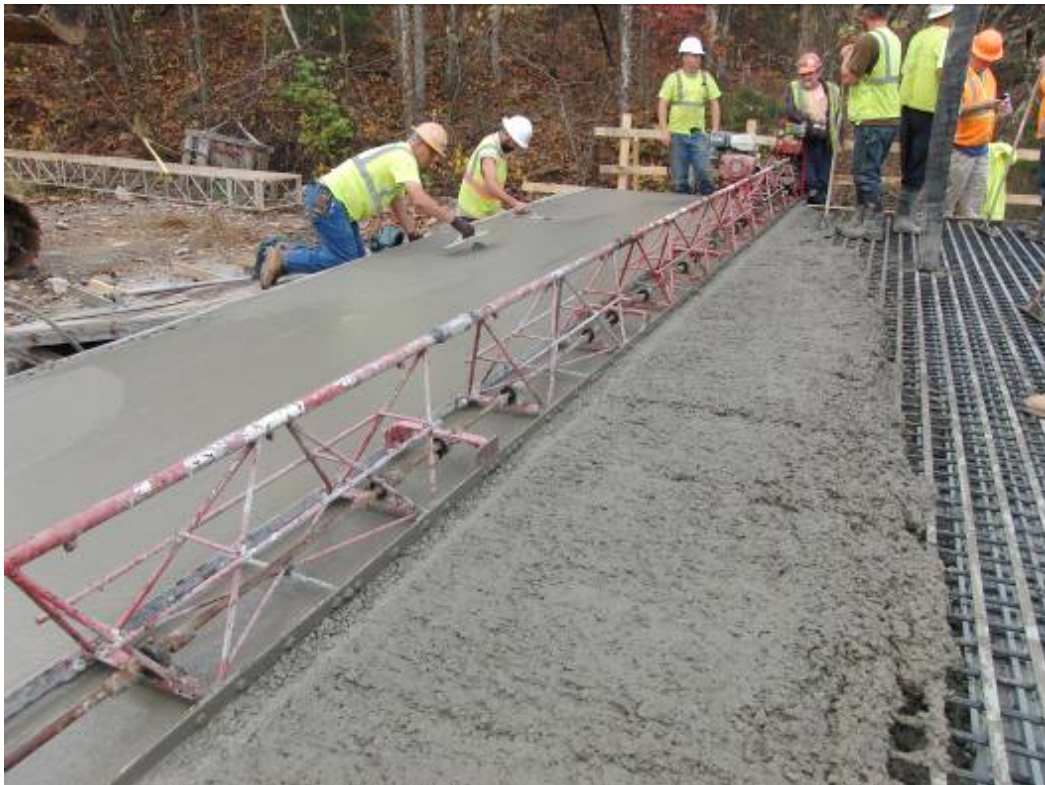
Figure 11. Spreading of concrete over the FRP reinforcement.

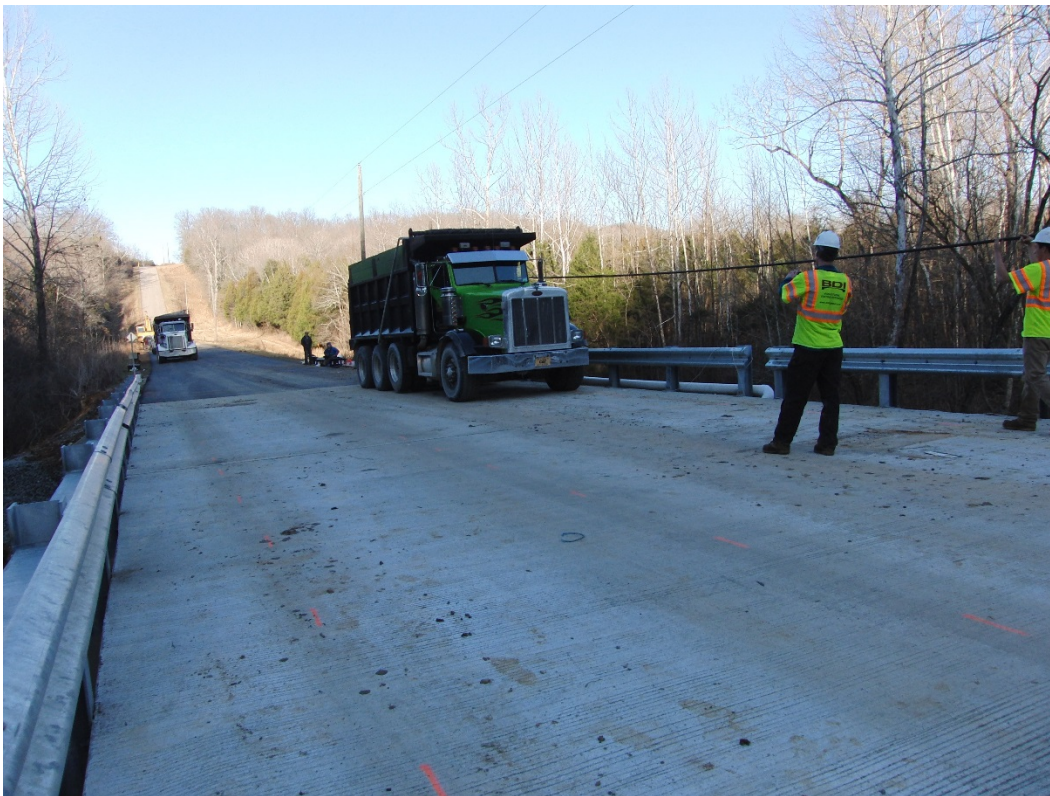
Figure 12. Finished bridge deck with the Gridform section in the foreground, and the conventional deck in the background (break is at the guardrail gap).

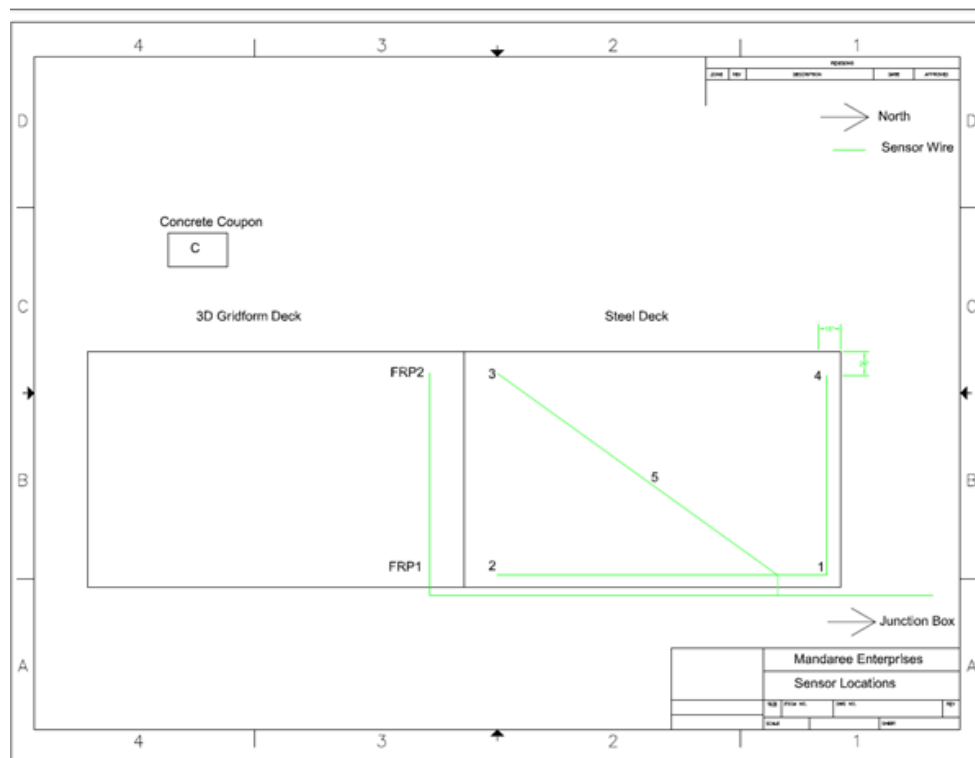
Figure 13. Corrosion sensor location plan view.

The corrosion sensors were installed in the bridge deck to measure chloride penetration, corrosion potential and corrosion rate. Measurements from the sensors were taken quarterly for a 12-month period. The selected sensors were Rohback Cosasco 900 Concrete Multi-Depth Sensors, Borin Stelth 7 sensors, and Rohback Cosasco 800 LPR Corrosion Rate sensors. The positions of the sensors are given in Table 2 and Figure 13.

Table 2. Corrosion sensor location key (see Figure 13 for location of sensors by span).

Location	Rohback Cosasco 900 Chloride	Rohback Cosasco 800 Corratel	Borin Stelth 7 Potential
1	X	X	X
2		X	X
3		X	X
4	X	X	X
5	X	X	XX
FRP1	X		
FRP2	X		
Salt Coupon	X	X

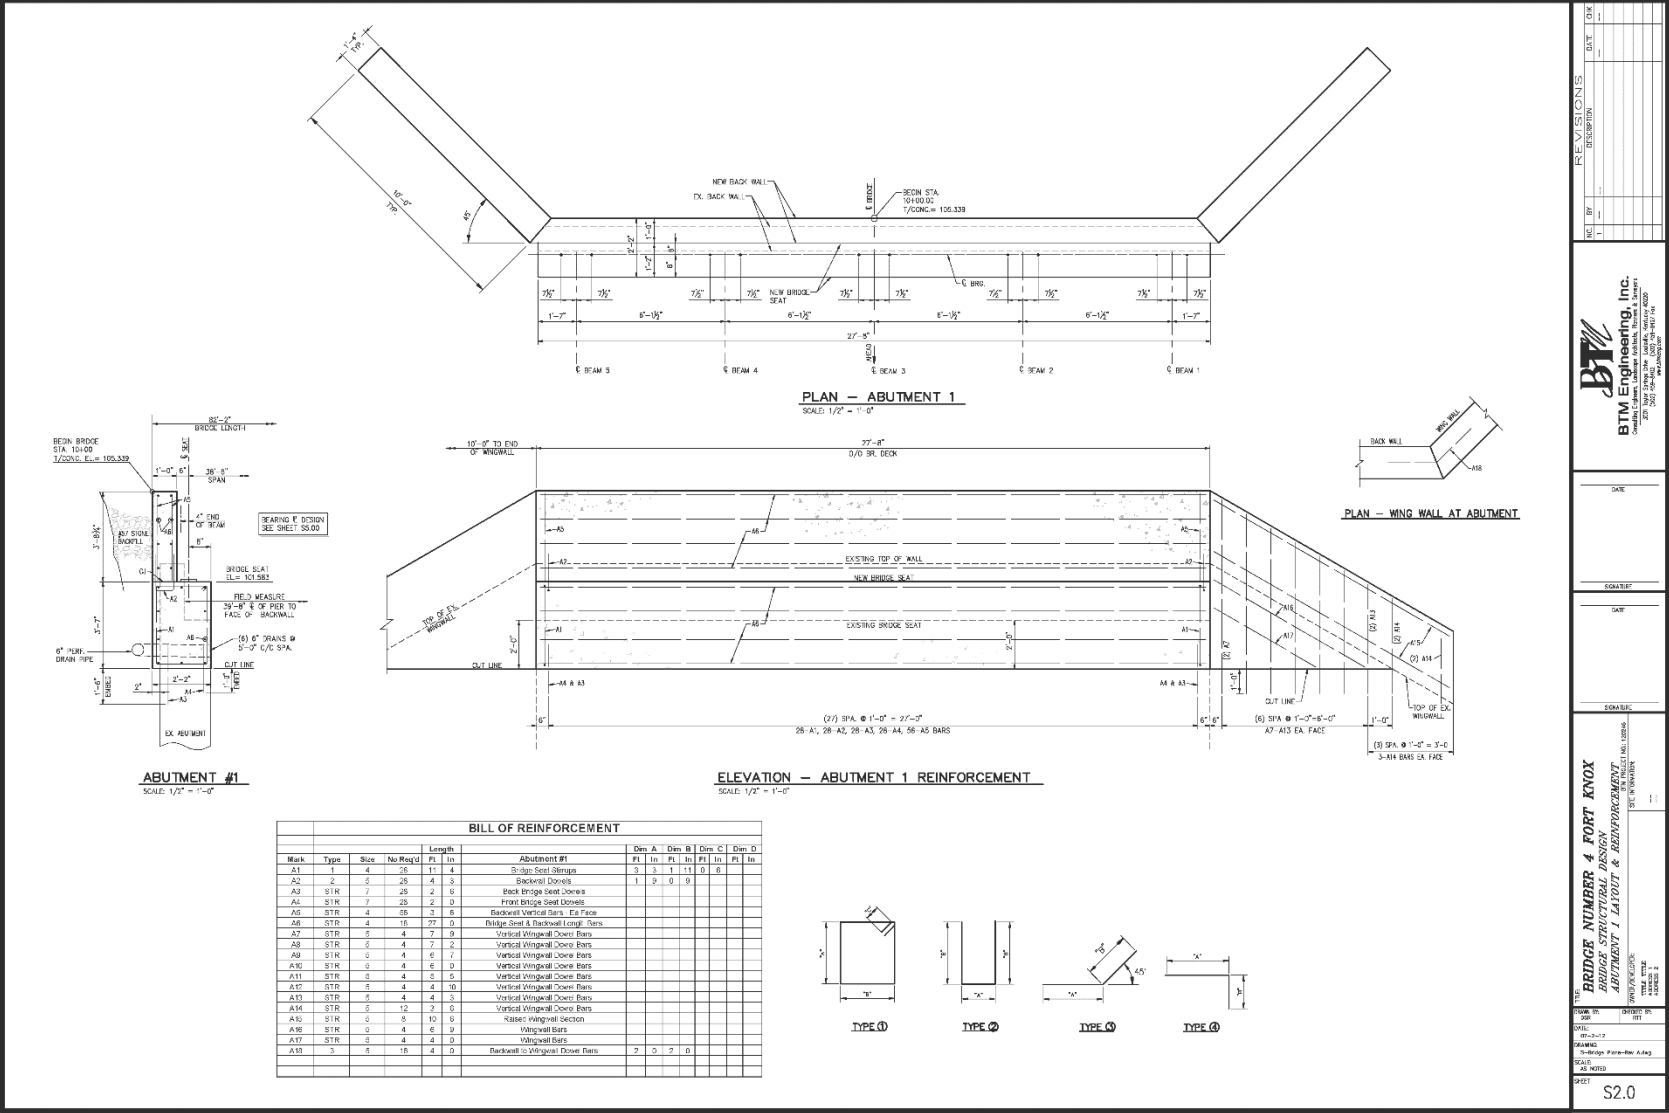
Figure A3. Engineer drawing for Abutment 1 on Bridge No. 4, Fort Knox.

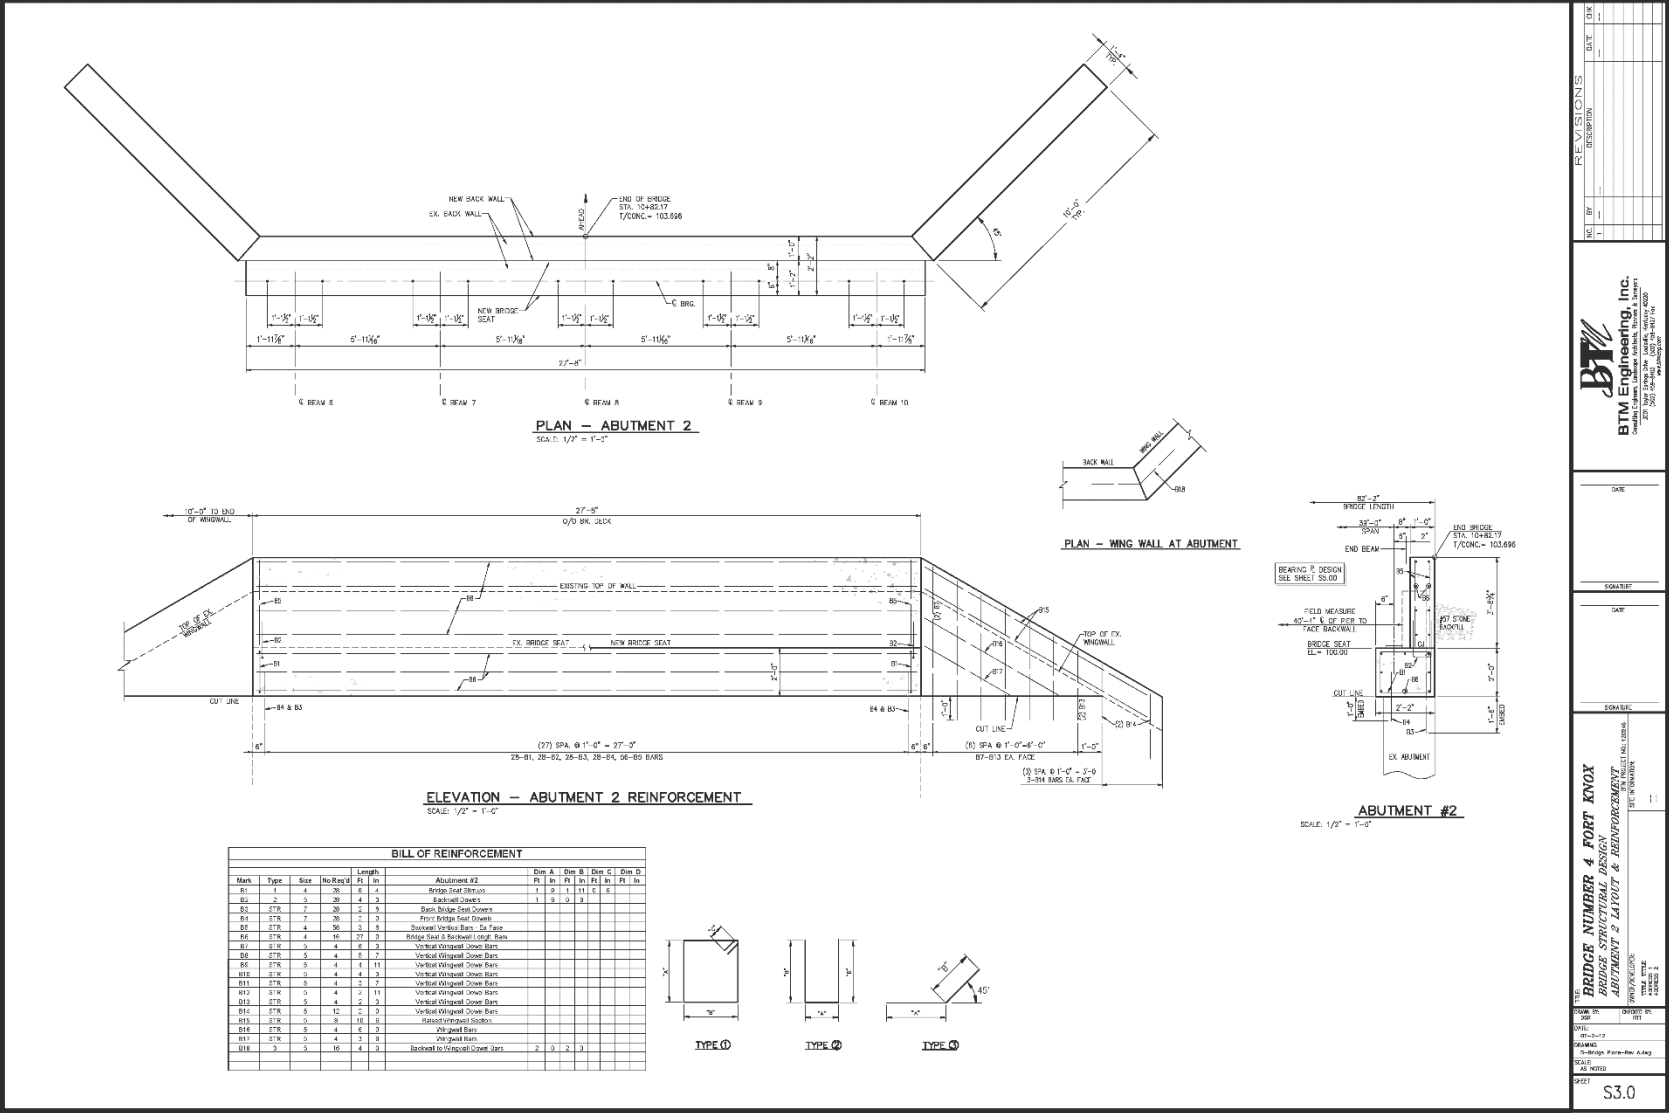
Figure A4. Engineer drawing for Abutment 2 on Bridge No. 4, Fort Knox.

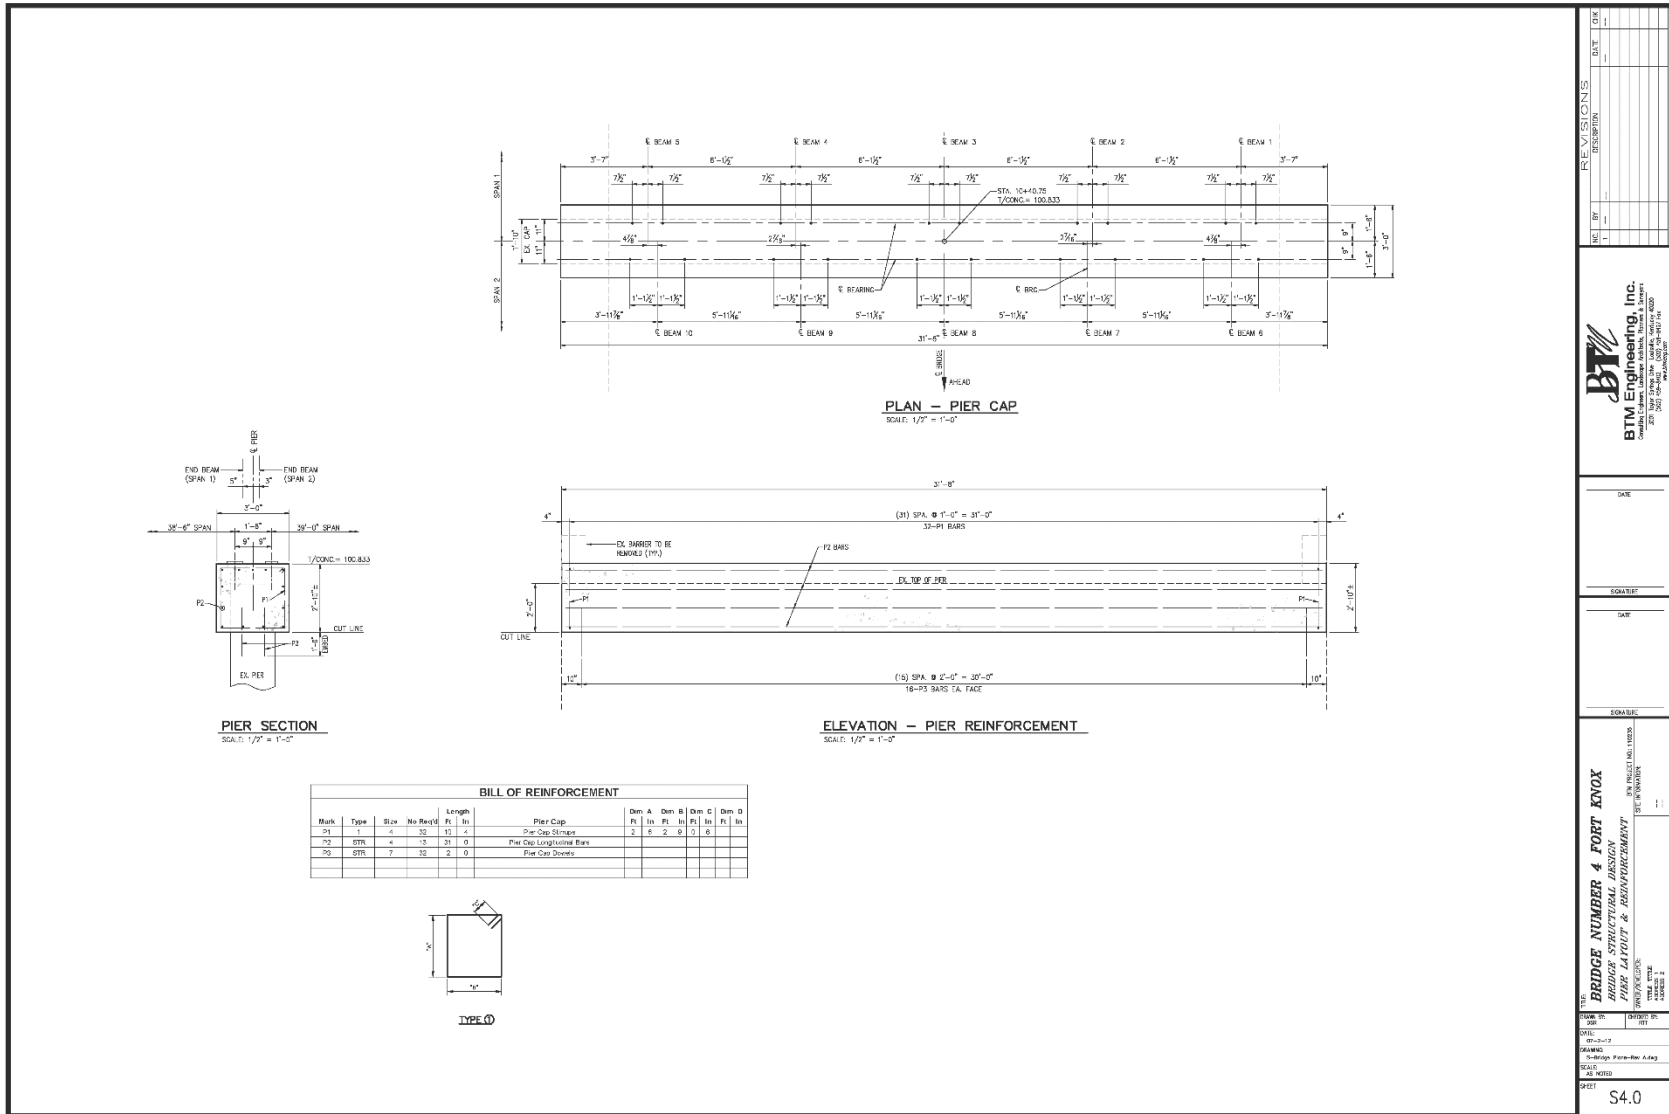
Figure A5. Engineer drawing for bridge pier on Bridge No. 4, Fort Knox.

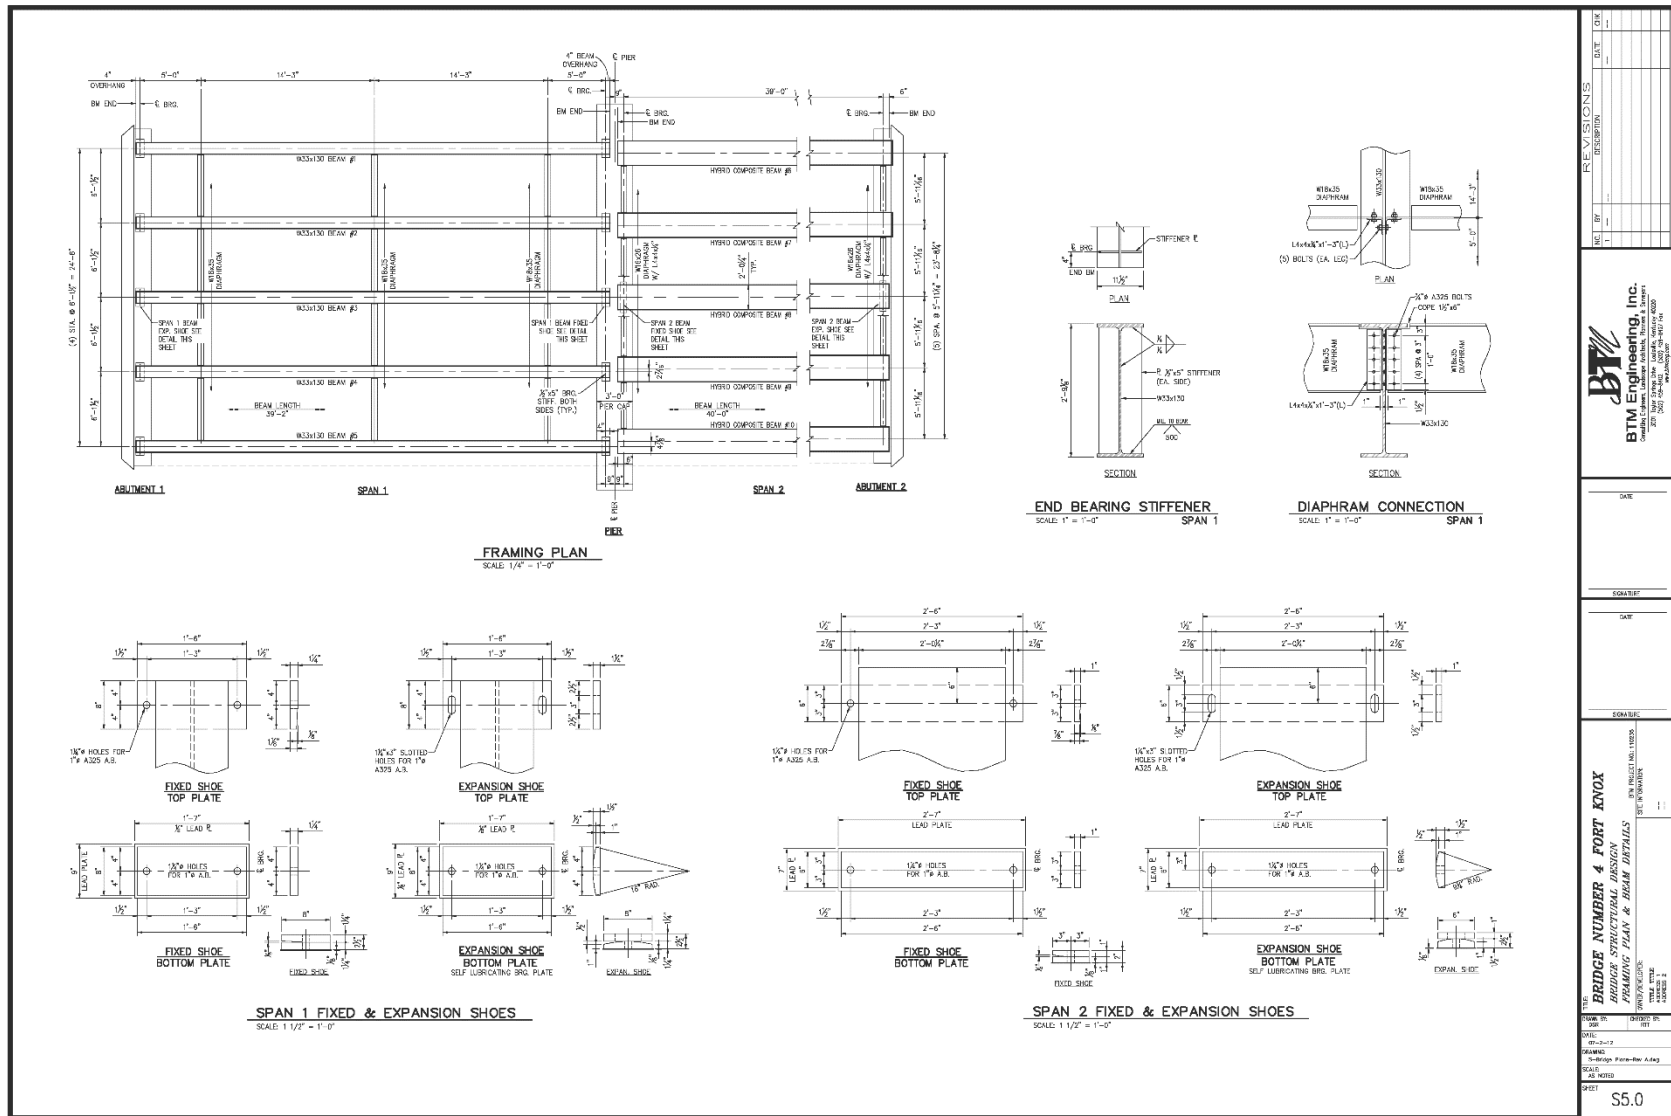
Figure A6. Engineer drawings for various design components on both spans of Bridge No. 4 at Fort Knox.

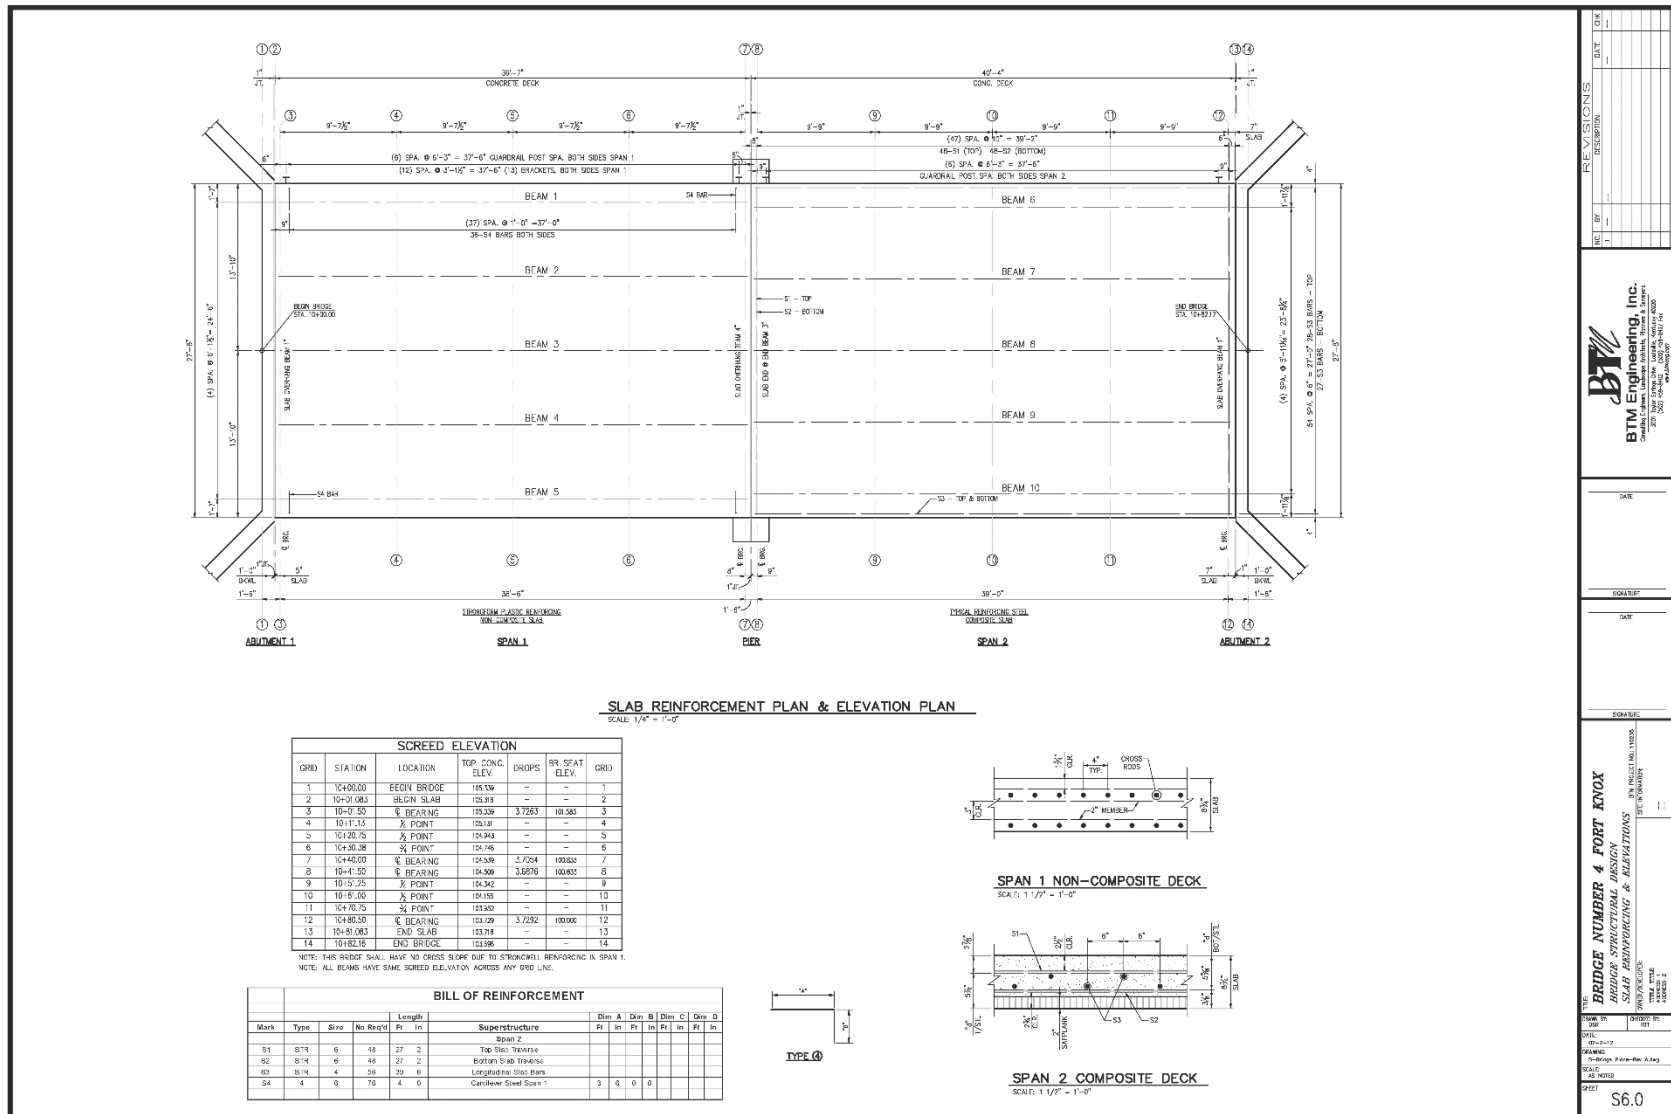
Figure A7. Engineer drawing for deck plans for both spans of Bridge No. 4 at Fort Knox.

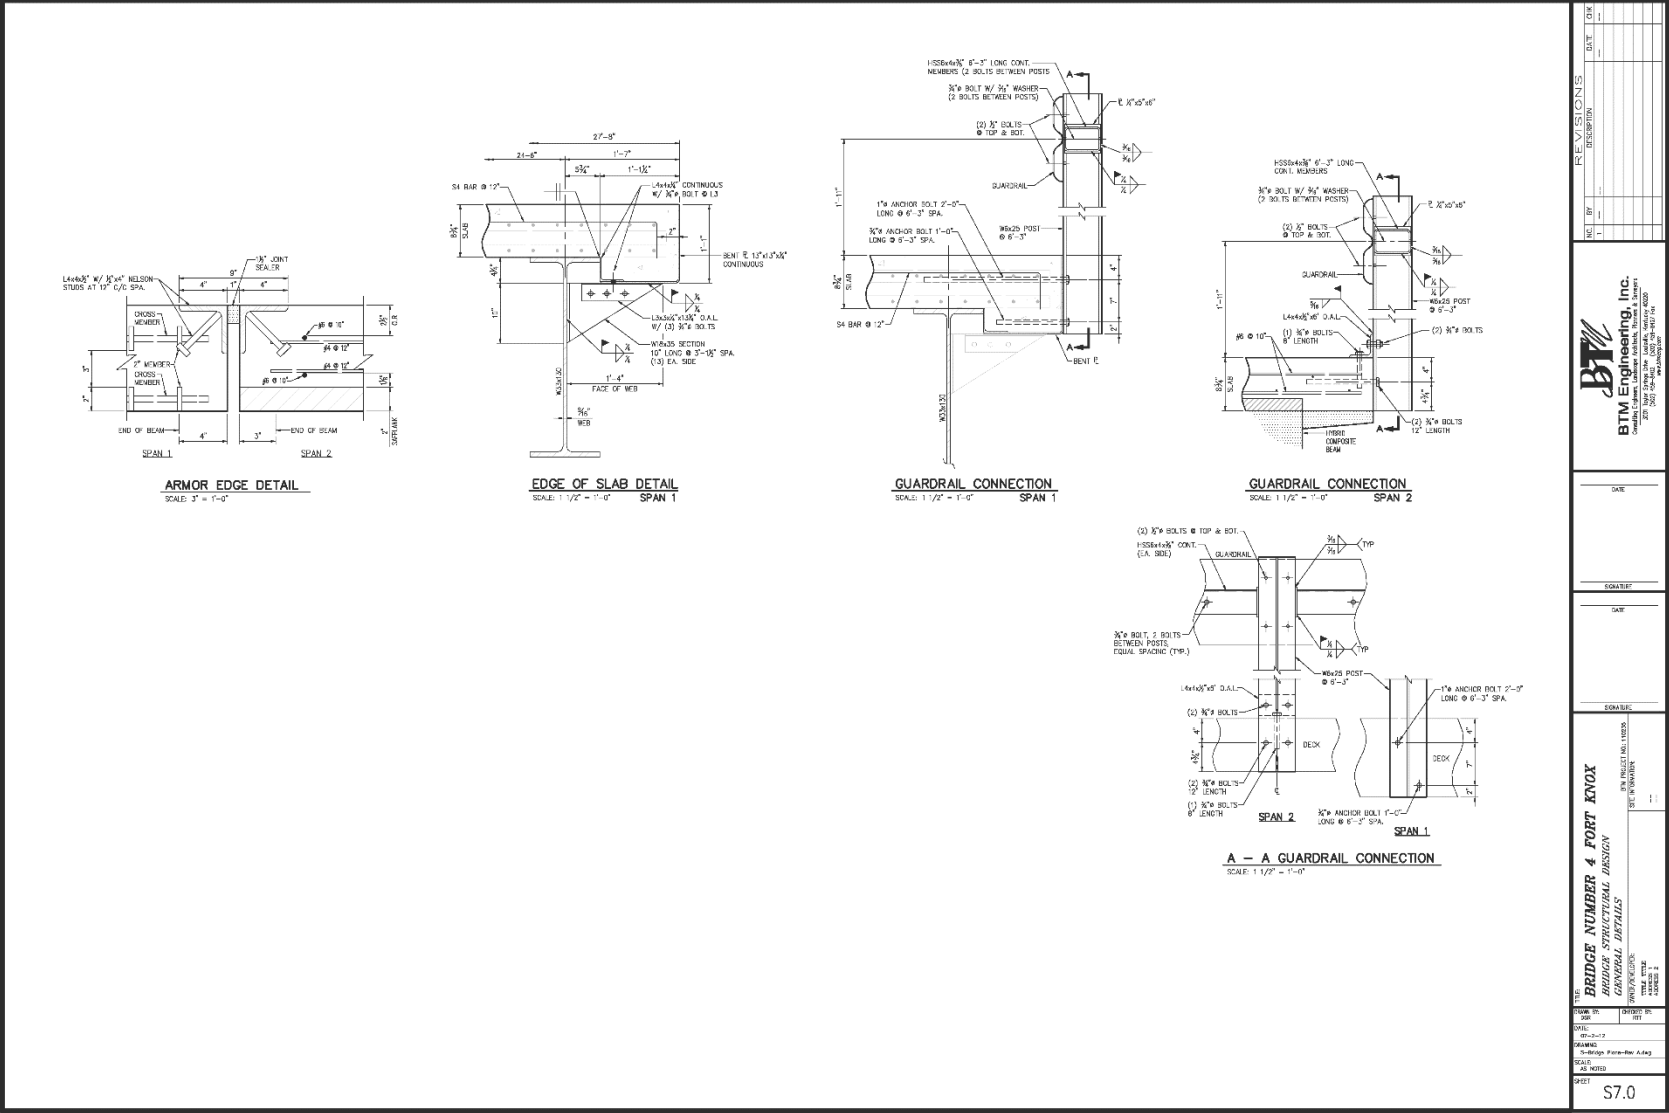
Figure A8. Engineer drawing for edge details and guardrail connections for both spans of Bridge No. 4 at Fort Knox.

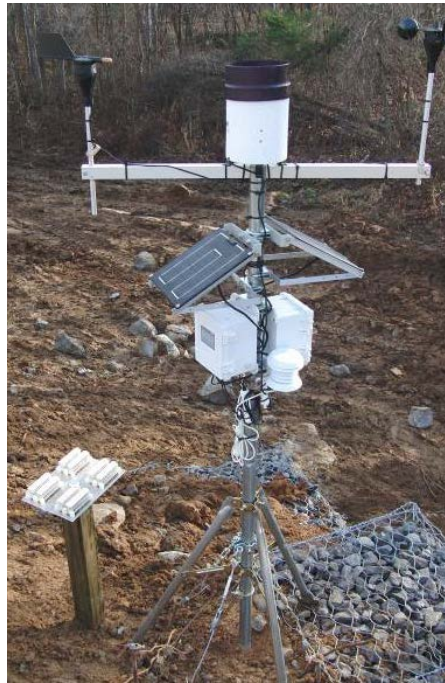
Figure B1. Weather station.

A weather station was installed to measure and record environmental characteristics throughout the exposure period as shown in Figure B1. The station measured temperature, relative humidity, wind speed and direction, and rainfall. The weather station was powered by a solar panel and a rechargeable battery. A data logger was used to store the measurements which were recorded every 12 hours by the rain gage and every 15 minutes for the remaining sensors. Data was downloaded manually during each quarterly inspection through the use of a laptop computer. The data logger has a storage capacity to continue storing data at 15-minute intervals for approximately 2.5 years. Upon reaching full capacity, the data logger will truncate the oldest data point to create room for new, incoming data.
